ACTION MEMORANDUM RV1

SUBJECT: Request for a Ceiling Increase, 12-Month Exemption, and \$2 Million Exemption for the Removal Action at the Charlestown Mall Site, Village of Frankfort, Herkimer County, New York

**U.S. EPA REMOVAL ACTION
CHARLESTOWN MALL SITE
FRANKFORT, NY**

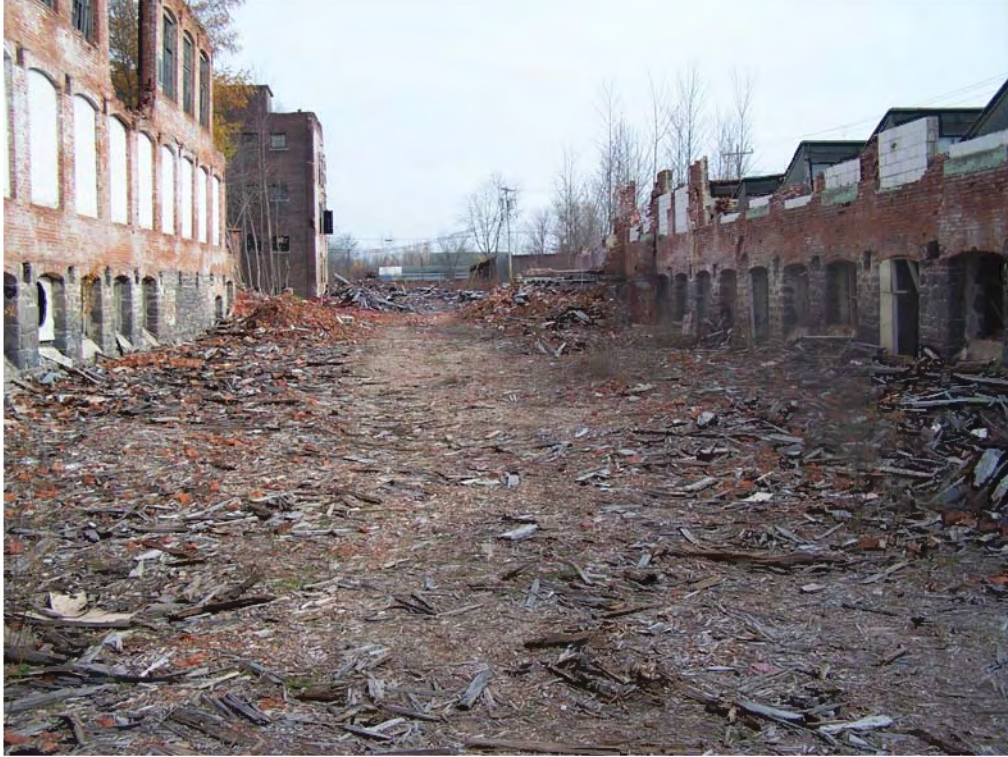
View facing East of the eastern half of former Bldg 3 prior to EPA removal activities.

Building 3 was unsafe because of the roof and free standing brick walls had collapsed. It was not surveyed.

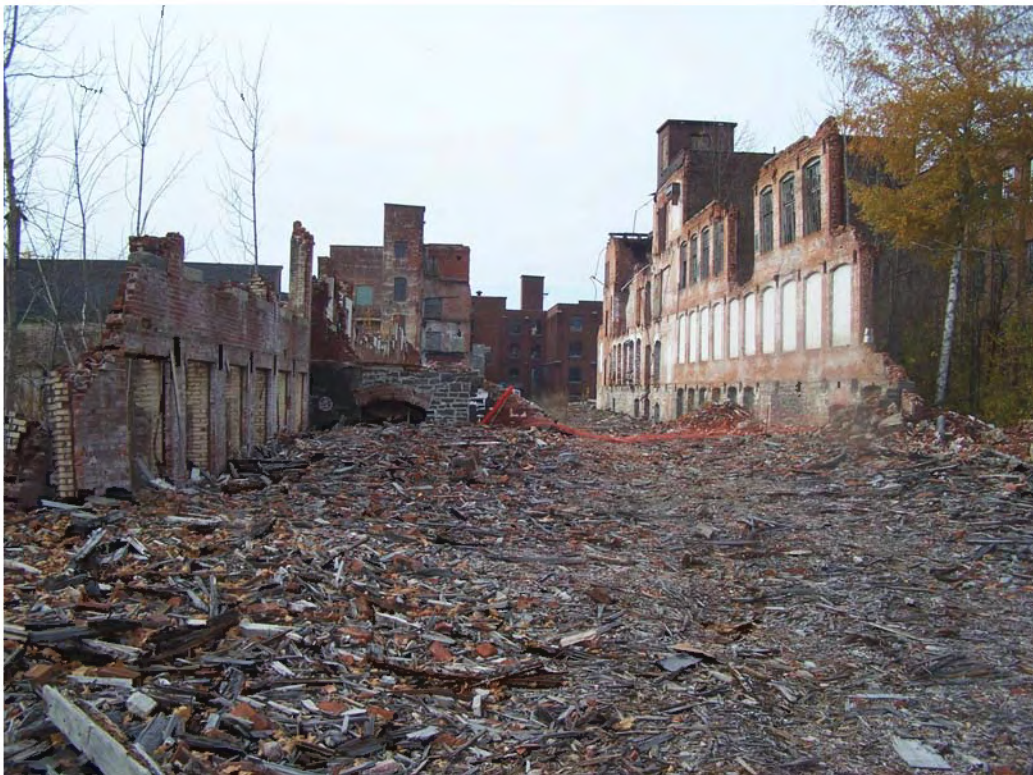
View facing West of the western half of former Bldg 3 prior to EPA removal activities.

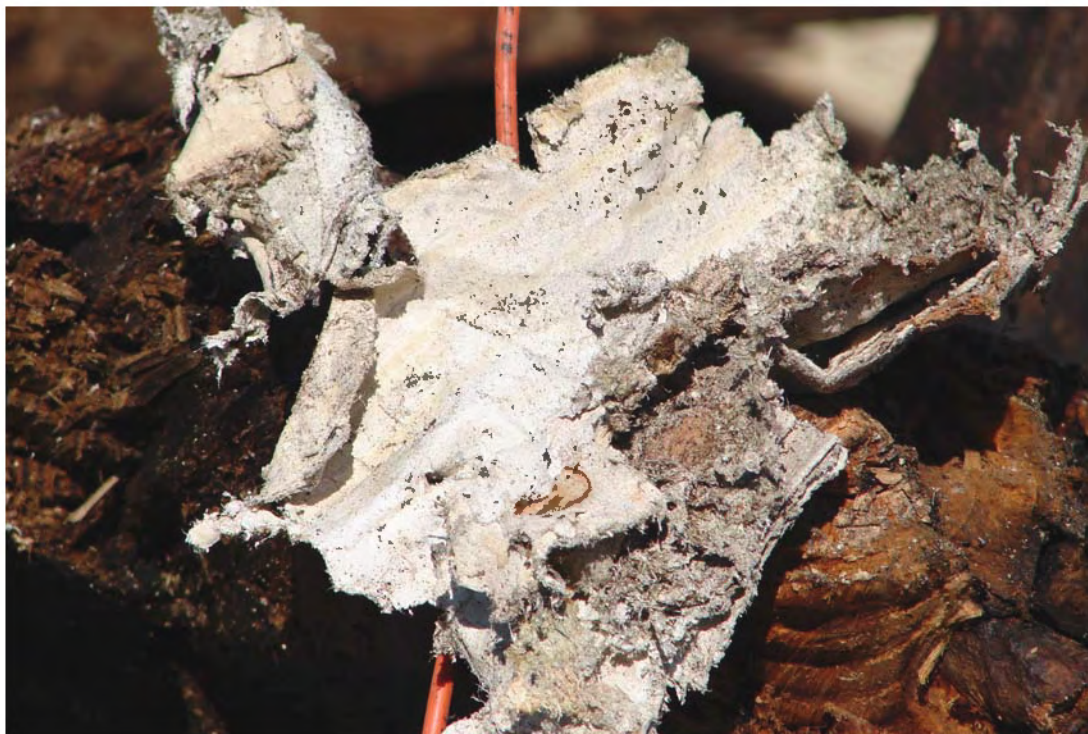
Asbestos containing material (ACM) identified in the Building 5 debris.

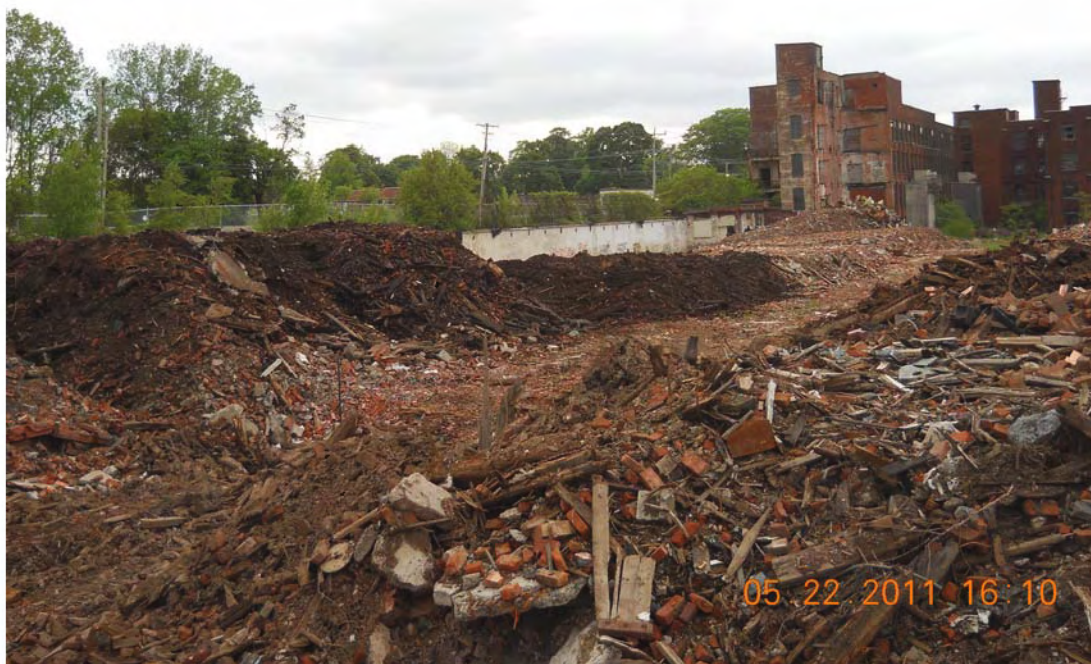
Asbestos contaminated demolition debris following demolition completed by EPA.
